Arm type ATC noise problem - quencharc

This documentation describes the possible causes and the solutions for arm type ATC failures in the field. The most common error messages are:

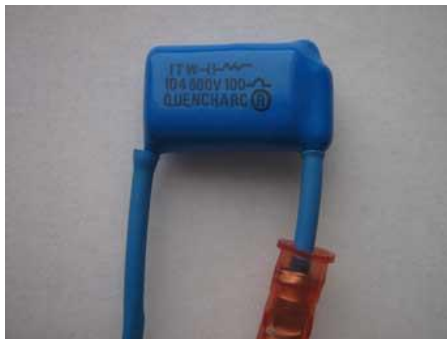
Figure 1, Pakron quencharc suppressor.

Electrical noise can be suppressed by adding a quencharc (figure 1) on the carousel and swing arm motor. Brake circuits on these motors are using two legs of the incoming 3 phases. A technician can add a quencharc across the two phases that the brake circuit uses, see figure 2, 3, 4, and 5.

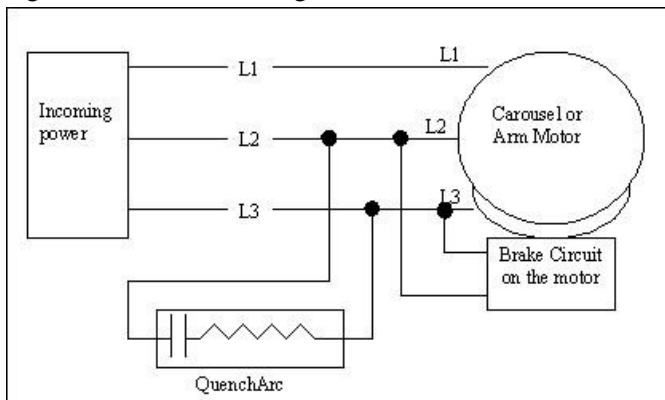
Figure 2, Connection diagram for carousel / arm motor

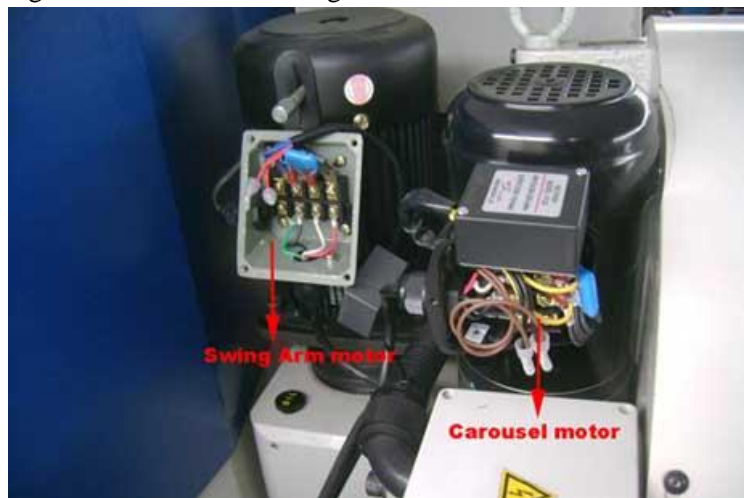
Figure 3, Overview of swing arm and carousel motor

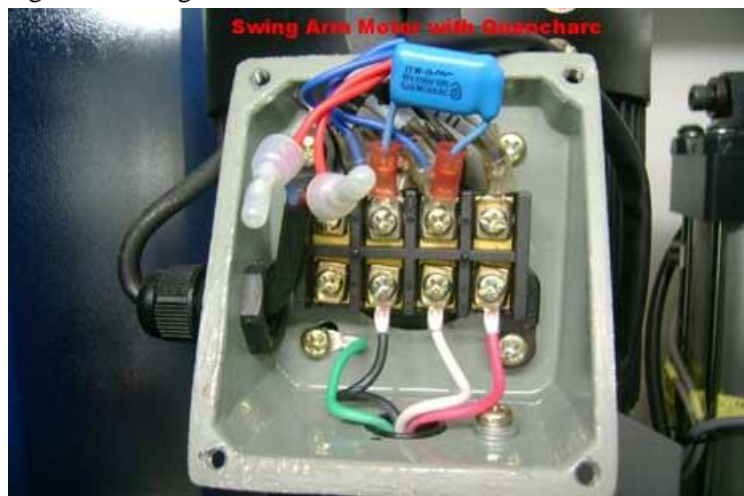
Figure 4, Swing arm motor

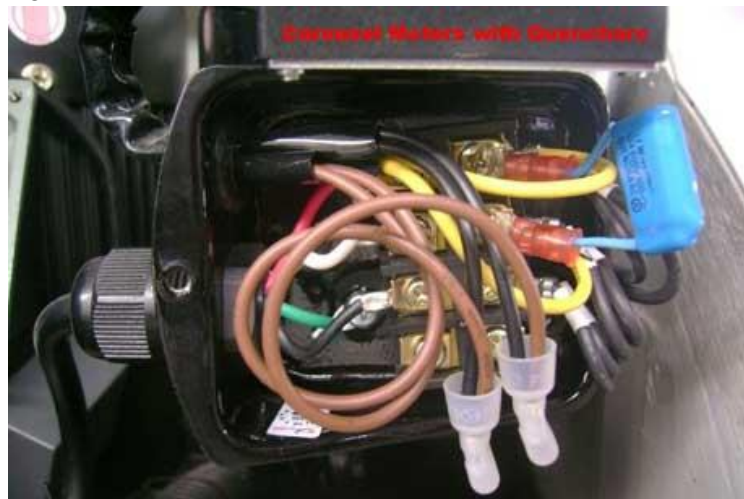
Figure 5, Carousel motor
